# CONDITION REPORT

ARTC025

| Title/Description | <i>Taxidermy Male Mallard Duck (Anas platyrhynchos)</i> |

| Owner or collection | Iron Hill Nature Center, Newark, DE |

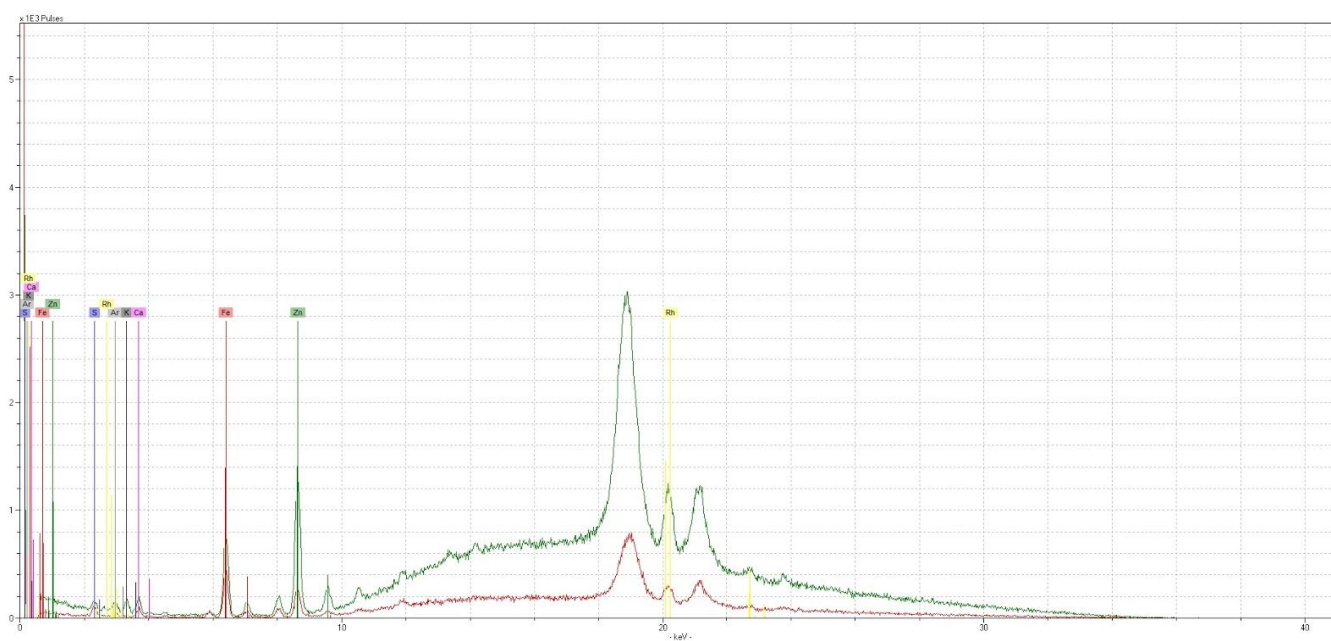
X-ray fluorescence, conducted on September 13, 2018 by Mariana Di Giacomo, showed little arsenic and no other heavy metal pesticides present on the specimen. In analysis from the head and breast of the duck the most prevalent elements were iron and zinc. In the legs, the most prevalent element was copper. This may have been detecting the inner wires of the legs.

The green readout is from the head of the duck. The red is from its chest.

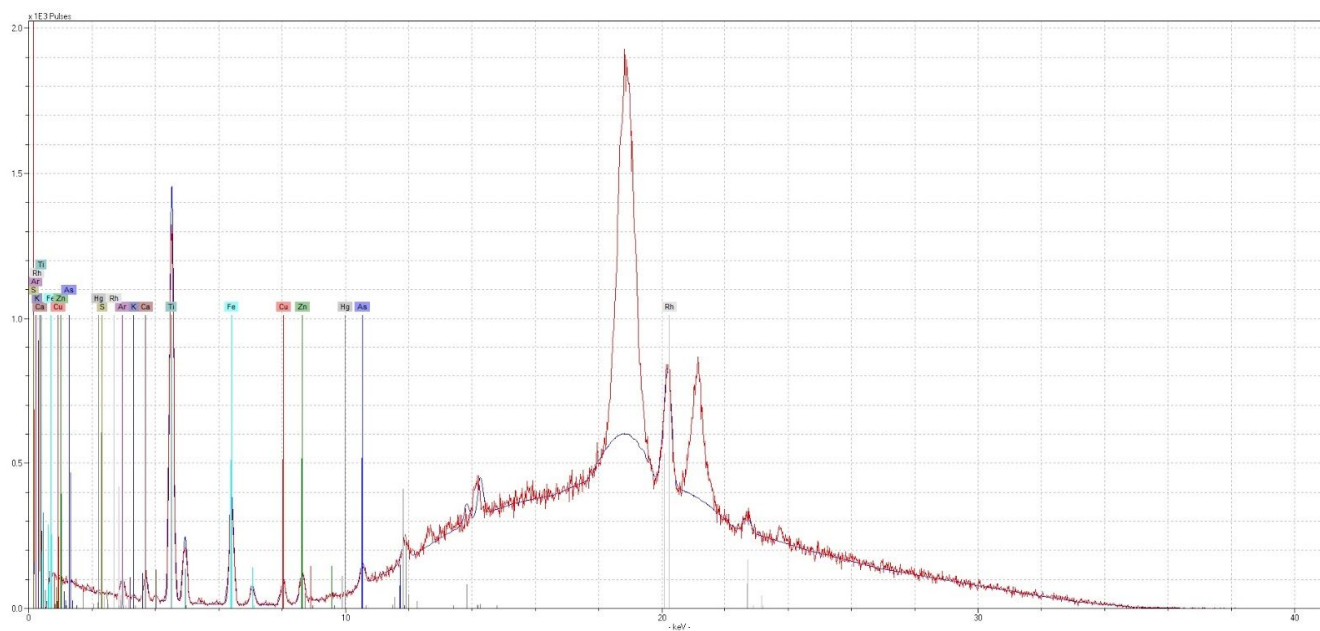
XRF Analysis of the left leg.
