ART CONSERVATION DEPARTMENT UNIVERSITY OF DELAWARE REPORT OF EXAMINATION AND PROPOSED TREATMENT

ARTIST: Unknown TITLE: *The Flower Shop* IDENTIFYING NUMBER: GACP 1723d EXAMINER: Vivien Barnett, Conservation Intern DIMENSIONS: 18" H x 14" W OWNER: Winterthur Museum EXAMINED: September 2018

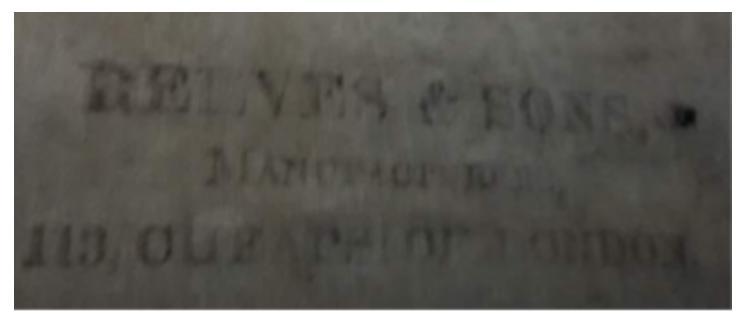
There is a canvas manufacturer's stamp on the recto of the canvas which is rendered more visible under Ultraviolet light. It reads, "REEVES & SONS,/MANUFACTURERS/113, CHEAPSIDE LONDON."

Manufacturer's stamp on the center of the recto of the canvas viewed under Ultraviolet illumination.

This company was established in 1766, and was located at 113 Cheapside in London from 1845 to 1940, meaning that this painting could not have been made prior to the year 1845.²

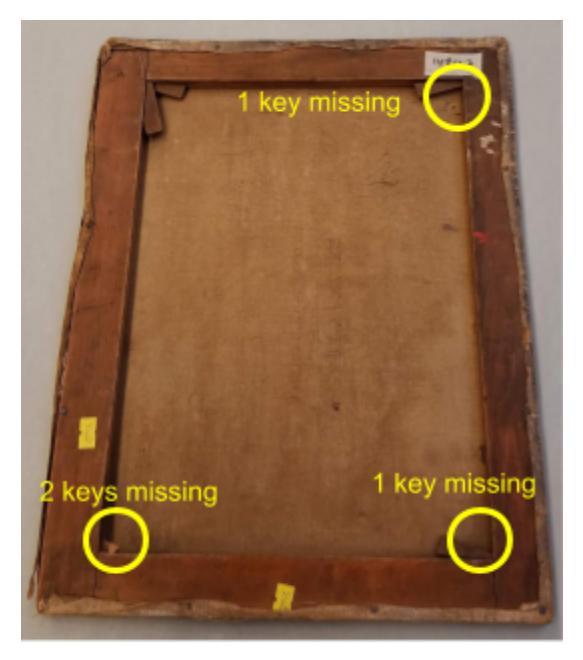
Painting recto and stretcher in visible light

The support is a plain-weave canvas, most likely linen, on a wooden stretcher. The canvas has a thread count of approximately 45 tpi. The stretcher is a mortise half-miter style with eight keyholes. However four keys are missing (one from the top PR, one from bottom PR, two from bottom PL). The canvas is attached to the stretcher with tacks on the sides and back of the stretcher (six on top, six on bottom, five on PR, two on PL [three missing]). There is overlapping foldover canvas on all four sides ranging from ½" to 3/8 " with some tearing along the tacking edge. The overlapping canvas is tacked to the verso of the stretcher.

Missing tacks should be replaced, missing keys should be replaced, and, after stabilization of the tacking edges, the stretched should be keyed out to tighten the canvas. The keys should be wired to the stretcher to prevent them from falling between the lower stretcher bar and the canvas.

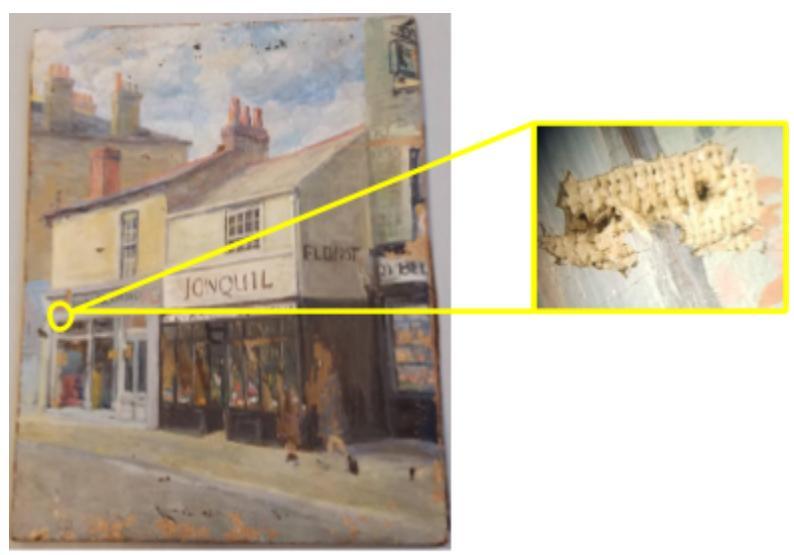
The canvas is in fair condition and has multiple holes. There are two small punctures in an area of paint loss on the bottom proper right quadrant of the painting, on the sign that says "JOHN RICHMOND."

Two small holes in the canvas viewed under microscope.

Flaking paint should be consolidated with warm, dilute BEVA 371 and a tacking iron. Holes and tears should be brought into plane with moisture and weights and then mended with Heiber-thread-by-thread reinforcements or Stabiltex and BEVA 371. The detached areas on the foldover edges of the canvas may need to have localized strip linings attached before re-stretching, perhaps through the use of a secondary support fabric such as Pe-Cap attached with BEVA 371.

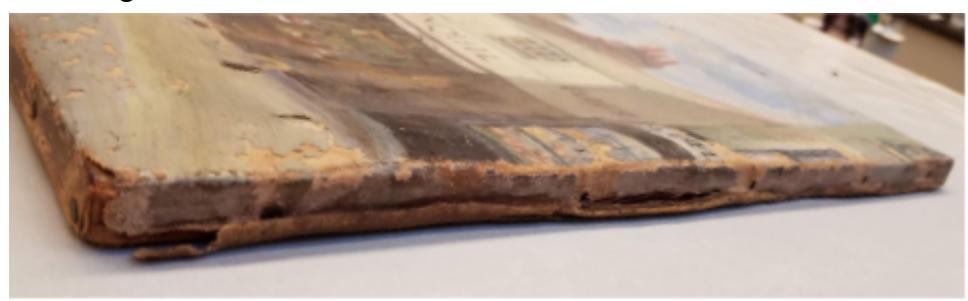
The brittle canvas is torn and splitting away from the auxiliary support on the proper left edge on the verso edge of the foldover crease, possibly due to excessive stress placed on the canvas during the stretching.

Proper left side edge of the painting verso showing tears and paint loss in the foldover canvas.

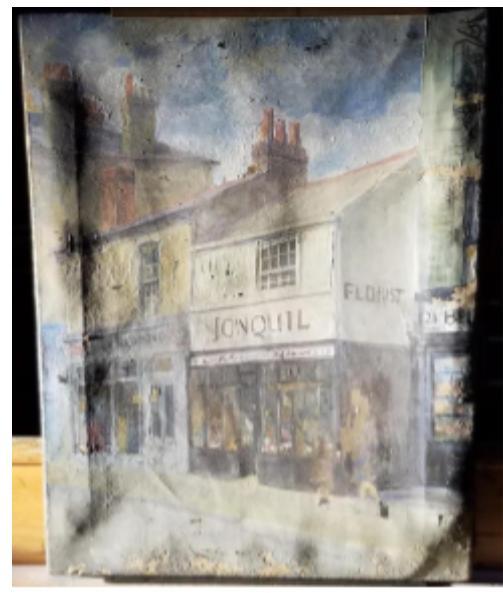
Painting verso under raking light

Due to the missing keys, the canvas has become loose and slightly billowing on the stretcher, resulting in a concave depression of the canvas. This is most evident when viewing the painting under raking light. A stretcher bar crease is especially visible on the left side in the photograph. There is much debris trapped between the lower stretcher bar and the canvas which is causing damage and paint loss along the bottom edge.

Debris trapped between the lower stretcher bar and the canvas should be removed immediately, possibly with feathers or a dull spatula.

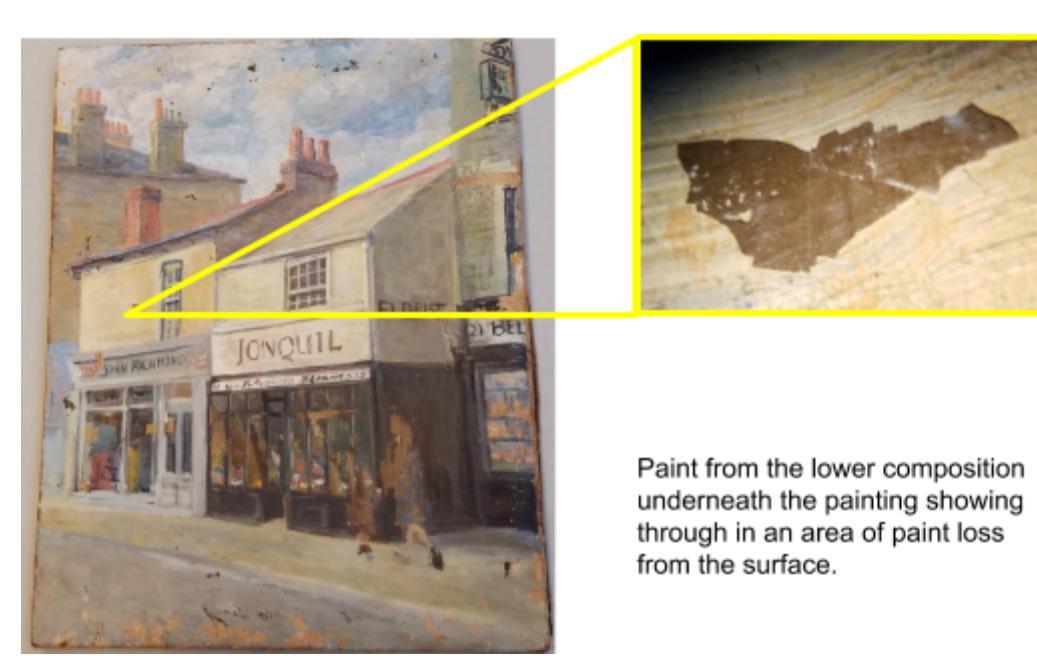
An off-white blue-gray ground is discernible on the foldover edges that have been primed. There is much flaking on the foldover edges, possibly from moisture damage, especially across the bottom. There is another painted image under the current one: a portrait. An underlying painting is evident due to the dark paint showing through areas of loss on the current painting. This painting was examined by Matthew Cushman. [DATE]

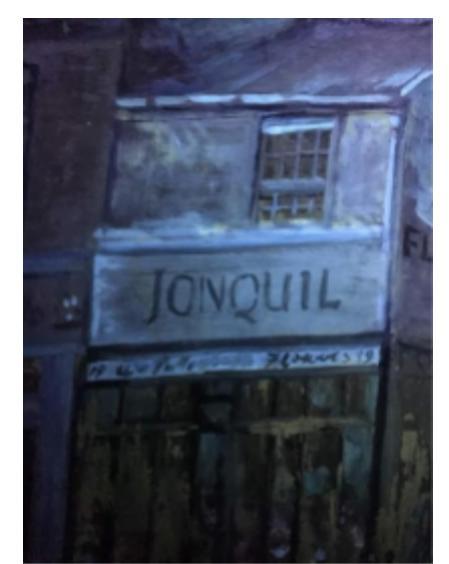
The topmost paint layer has significant losses all over the canvas, mostly along the foldover edges over the stretcher and in the bottom half of the image. This damage was most likely cause by water damage, as mentioned above, and by the distortions caused by debris trapped between the canvas and the stretcher, as also mentioned above.

The florist shop viewed under UV light.

The painting does not appear to be varnished or have any visible overpaint or other foreign surface accretions when viewed under visible or UV illumination. The fluorescence shown in the image to the right corresponds to the white pigment used for the highlights in the painting (possibly zinc white), rather than the presence of a varnish.

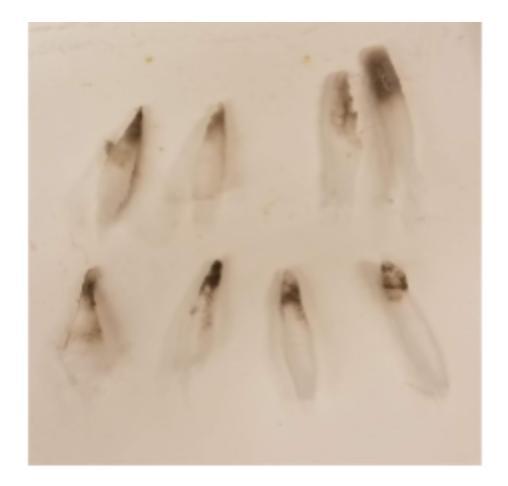
Solvent testing the surface with a mild enzyme solution showed a layer of grime that is spread across the surface of the painting. Further solvent testing using citric acid (pH 6) and then rinsed with a mild enzyme solution was more effective at removing this layer of grime. The swabs were taken from different areas along the proper right edge of the

painting to survey the accretion over different pigments and levels of impasto across the surface.

Top row: Citric Acid (pH 6) swabs Bottom row: Mild enzyme solution swabs
