ART CONSERVATION DEPARTMENT UNIVERSITY OF DELAWARE REPORT OF EXAMINATION AND PROPOSED TREATMENT

ARTIST: Unknown TITLE: *The Flower Shop* IDENTIFYING NUMBER: GACP 1723d EXAMINER: Vivien Barnett, Conservation Intern DIMENSIONS: 18" H x 14" W OWNER: Winterthur Museum EXAMINED: September 2018

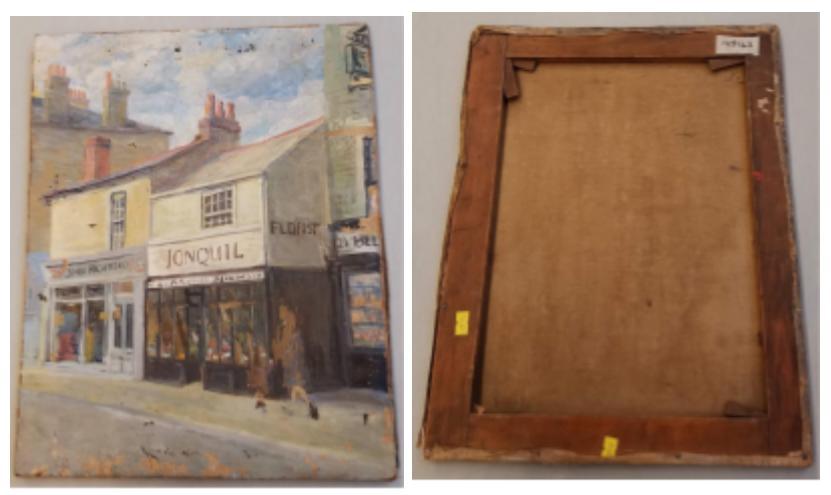
The brushwork used to create this painting shows high impasto in some areas of the painting, and the brushstrokes are rather visible upon close inspection. This is especially noticeable in the sky and clouds in the upper section of the painting when viewed in raking light.
