# CONDITION REPORT

ARTC025

| Title/Description | <i>Taxidermy Male Mallard Duck (Anas platyrhynchos)</i> |

| Owner or collection | Iron Hill Nature Center, Newark, DE |

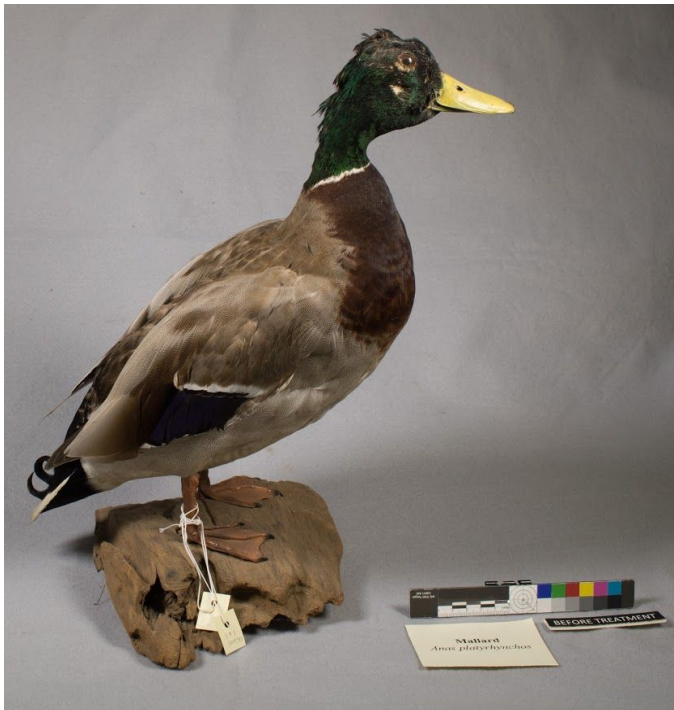
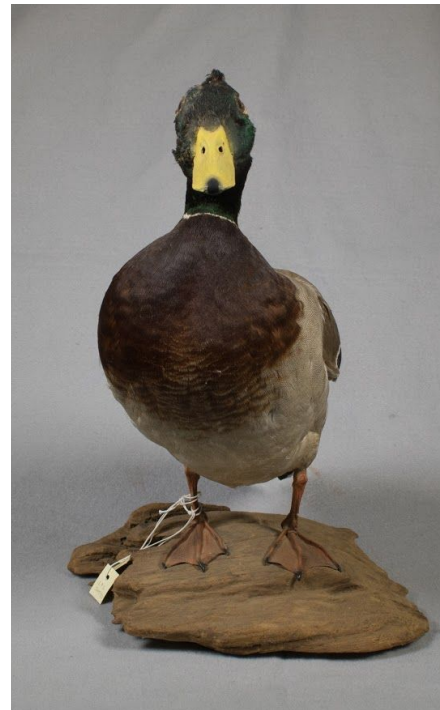
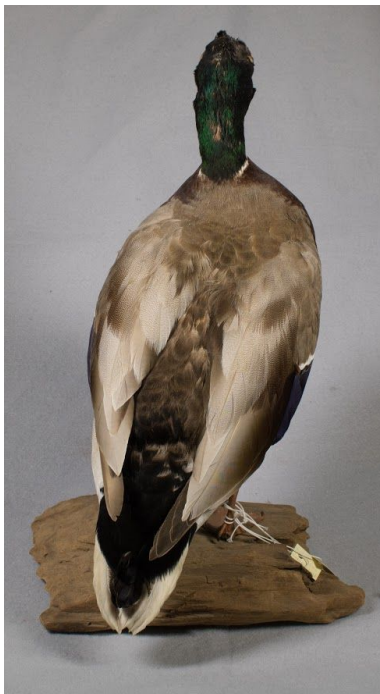
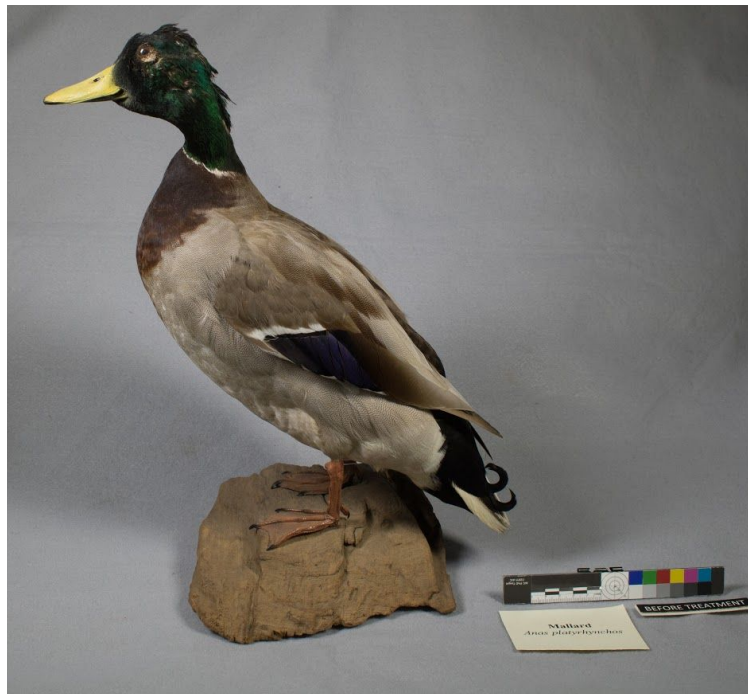
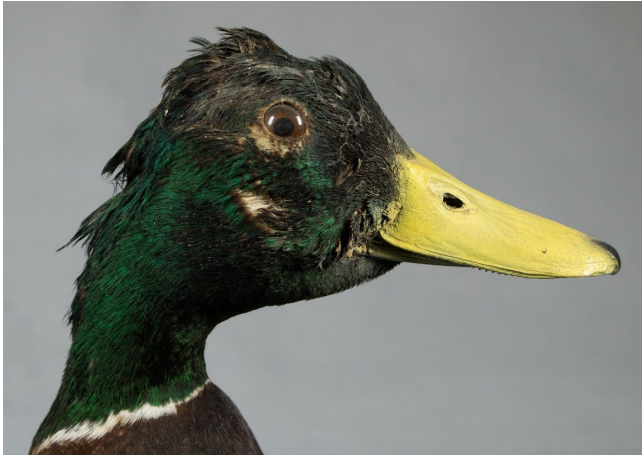
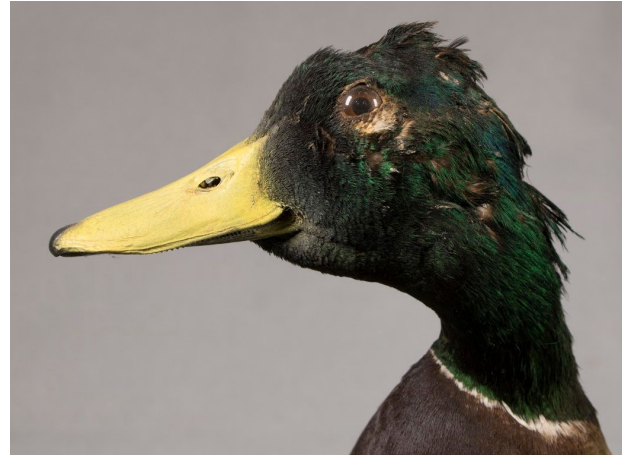
## PHOTOGRAPHIC DOCUMENTATION

The specimen is stable overall, with no visible fading of the feathers. It is covered in surface grime, and there are cobwebs on its head feathers. Desiccated insect casings were found within the damaged head feathers, adjacent to the exposed support wire which is protruding from the top of the head. The yellow paint from the bill is also on the surrounding feathers. The head feathers are ruffled and matted, particularly behind the eyes and along the back of the neck. The eyes seem too large for the head and are slightly bulged. The majority of the body feathers are intact, with only slight ruffling on the breast and back. However, the right wing appears to be in a different position than the left wing, and perhaps was displaced during previous handling or transport. It is unknown if the leg and feet are the original bird skin. They appear painted and have some minor areas of loss on the legs. The driftwood base is stable but covered in surface grime.

- Complete initial photography and documentation.
- Vacuum and brush feathers overall using HEPA vacuum to remove loose surface grime.
- Brush legs and driftwood base to remove excess surface grime.
- Comb all feathers to remove embedded surface grime and reposition feathers.
- Using cosmetic sponges, reduce remaining grime where necessary.
- Humidify disturbed feathers on head using deionized water. Use solvents if necessary.
- In flaking areas on legs and feet, consolidate using low-concentration solution of Paraloid B72 in acetone.
- In areas of loss on feet and legs, inpaint using acrylics.
- Clean glass eyes with deionized water applied on a cotton swab.
- Complete final photography and documentation.
